Implementing Accessibility

The ROADEX IV Project

Timber Transport Forum Conference 2010

ROADEX Update

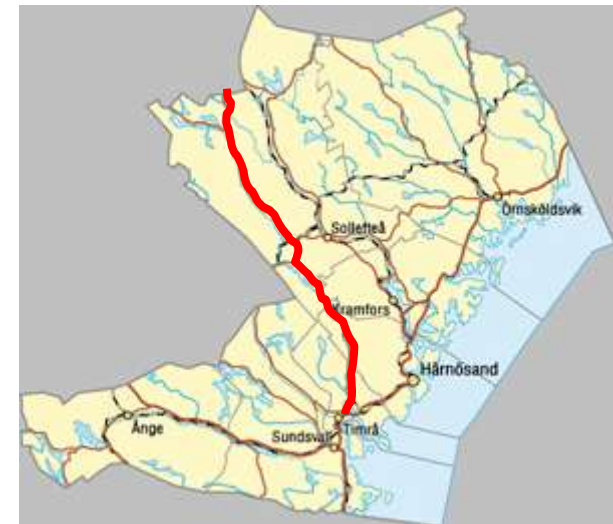
Vibration tests on Road 331

“The Beaver Road”, northern Sweden

- **170 km 2 lane regional route**
- **Daily traffic of 350 to 2,000 vehicles per day.**
- **Speed limits of 70 and 90 km/h, 50 km/h through villages.**

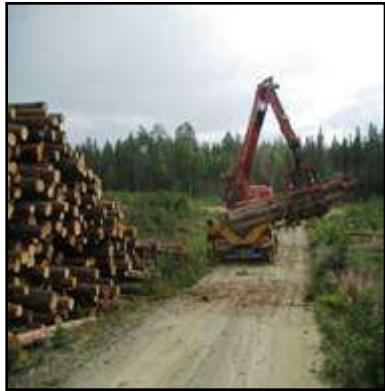
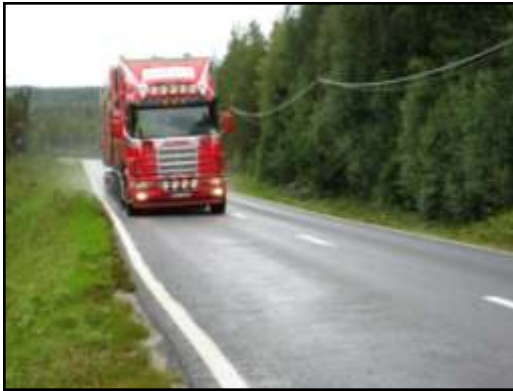
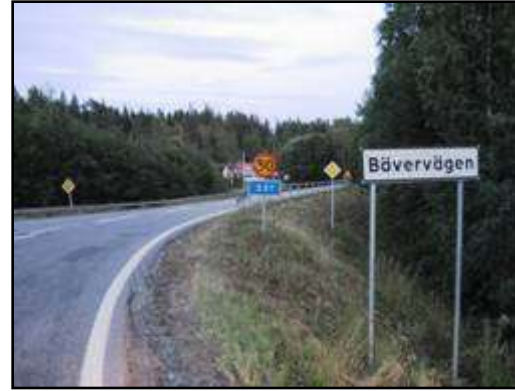
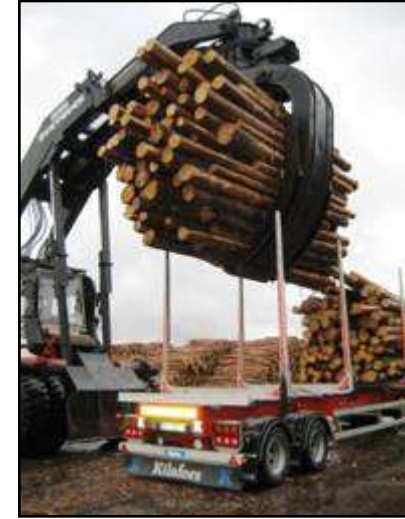
The truck ride sensors:

Z-axis 1 kHz at L and R frame.

Z-axis at L and R front wheel axles.

**GPS + 6-axis 100 Hz
inertial unit in the cab.**

X, Y, Z-axis 1 kHz seat pad.

Videocamera for visual reference.

Microphone for interior noise < 5 kHz.

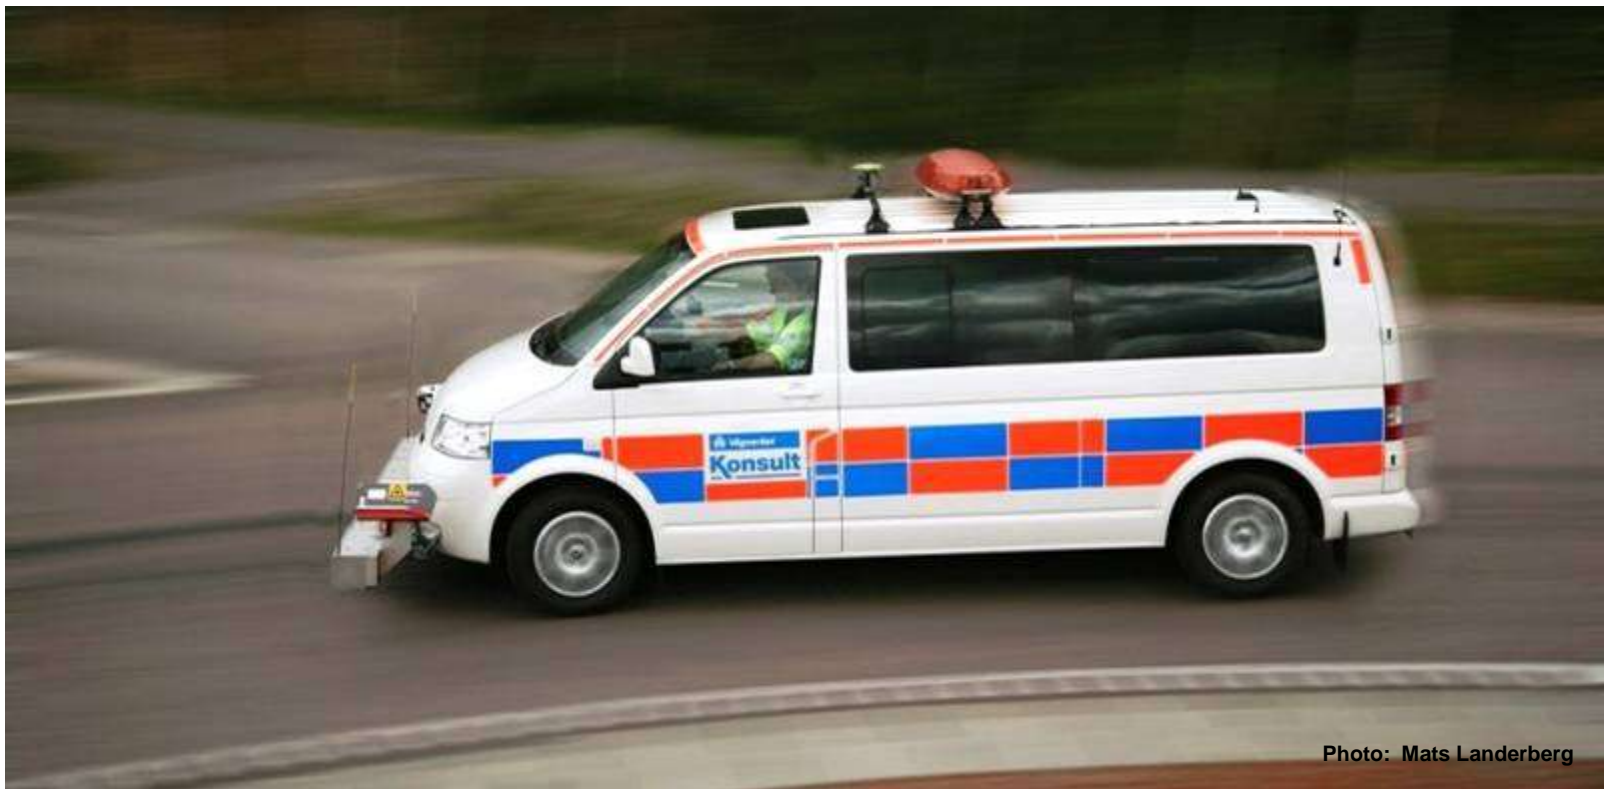
Road surface measurement

A laser/inertial Profilograph scanned the test road's surface condition 20,000 times per metre.

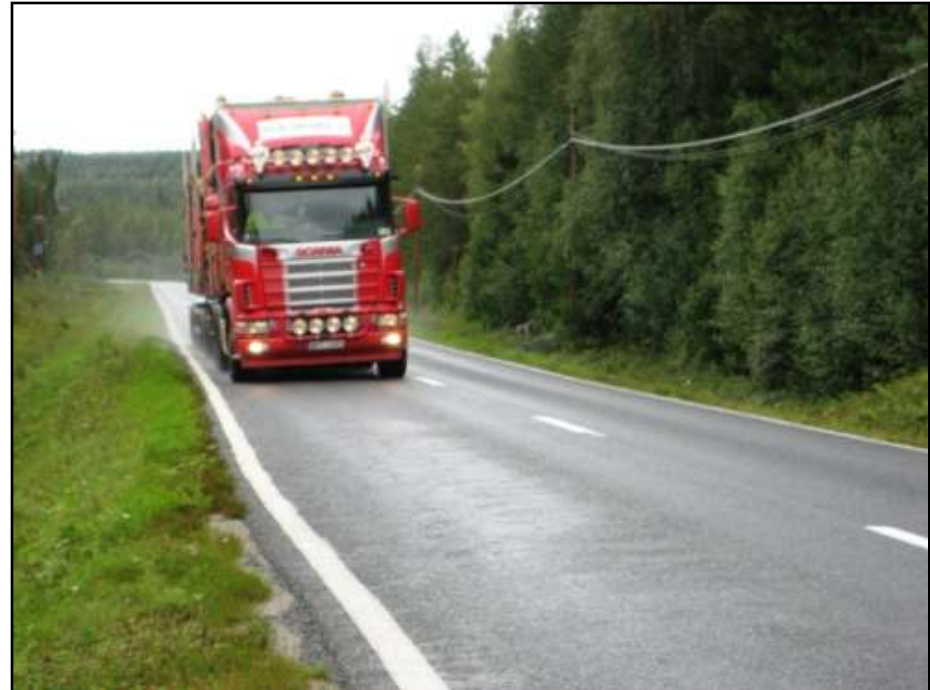
“Rock n’ Roll” at Backe:

Note the warping between the truck and the trailer.

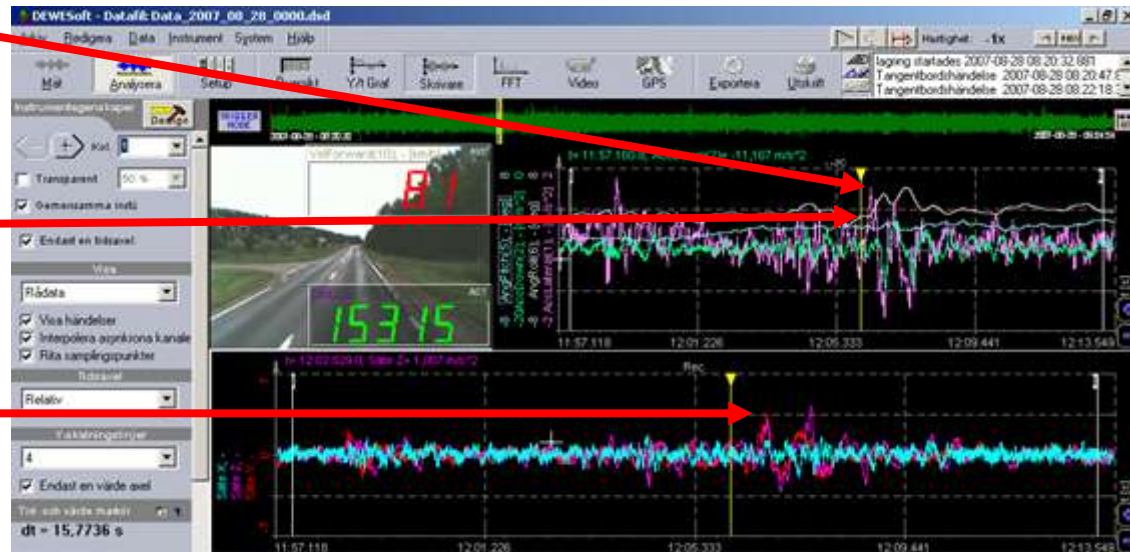
“Rock n’ Roll” on the Åkerö straight:

Truck cab roll angle:

**- Very high rate;
5°/s (at high freq).**

**High lateral acc in
cab: 2 m/s².**

**Very high lateral acc
at the driver seat:
3.5m/s² (+ 75 %)**

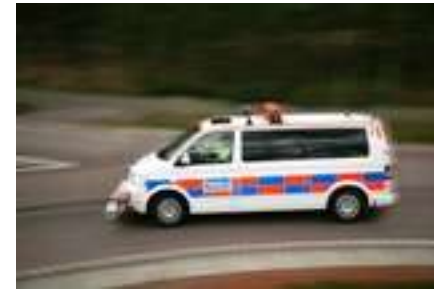
Typical 3D laserscan of edge deformation at Åkerö:

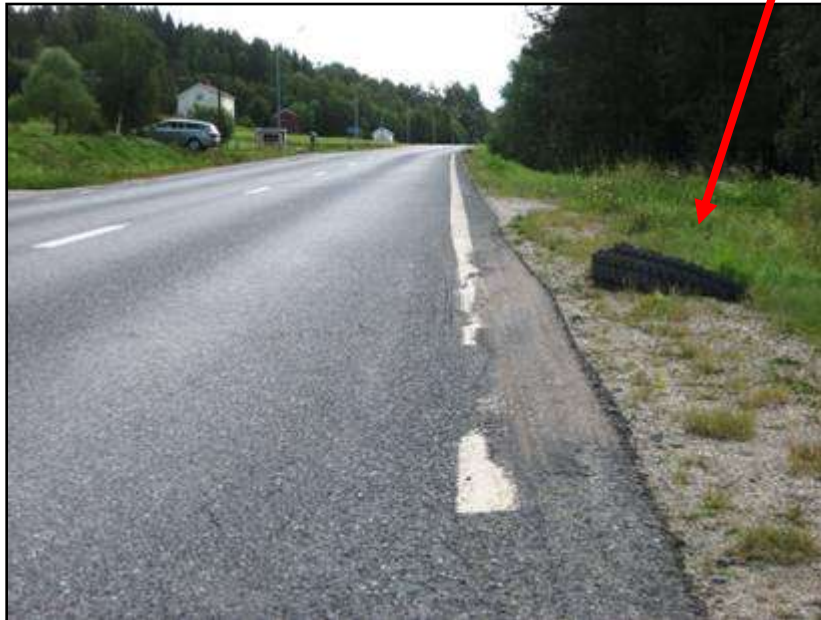
Note: Exploded truck tire

The 1.18 % RBCS variance was caused by a 69 mm deep deformation

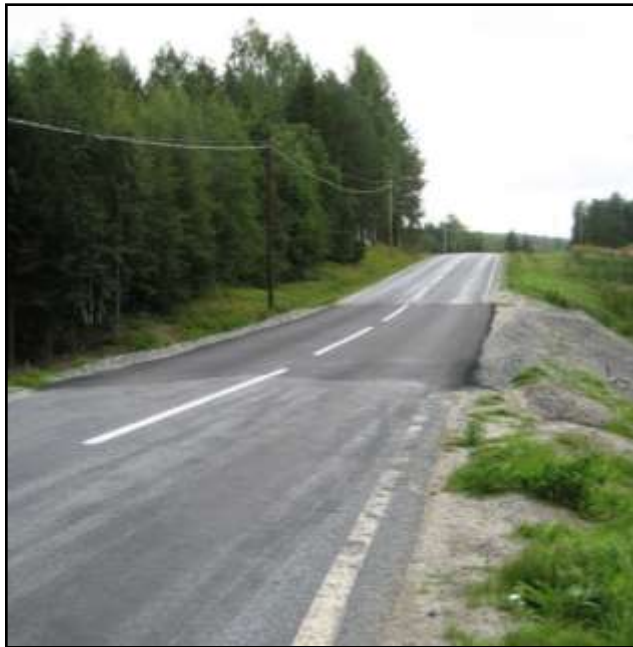
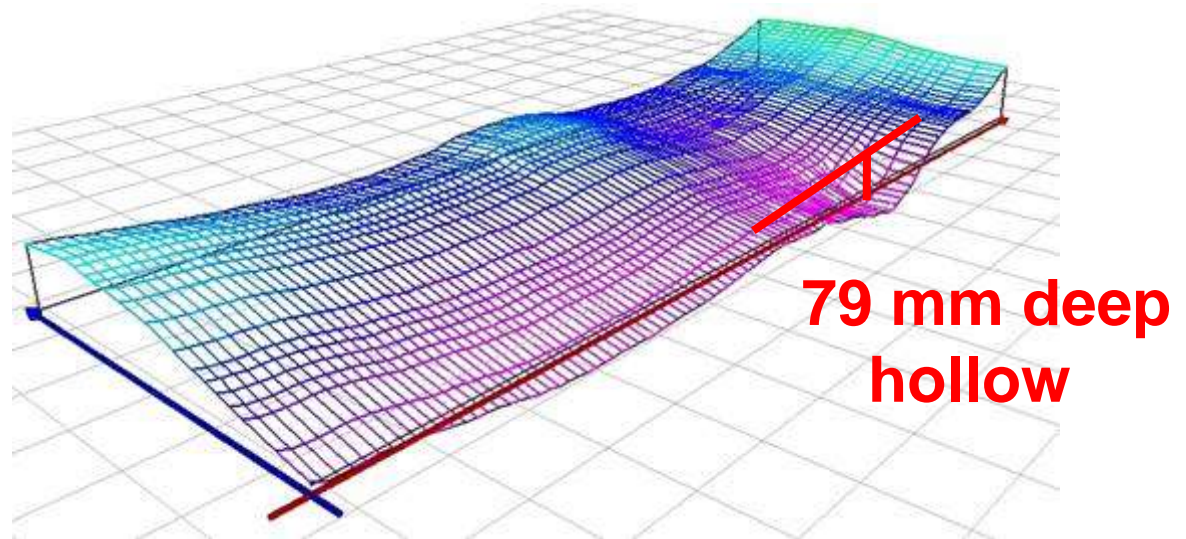
Bumps at culverts:

3D laserscan of settlement at a culvert repair

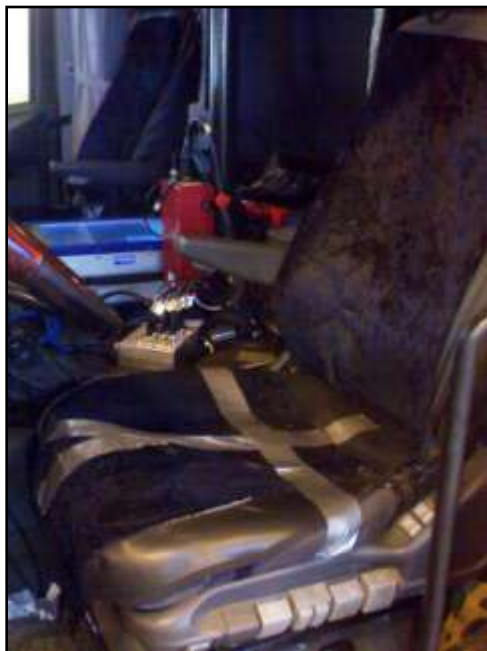
Average daily vibration exposure A(8) (EU Directive 2002/44/EC)

Results for normal driving shifts, taking roundtrips from the forests to the coast:

A(8) = 0.76 m/s², over EU Action Value 0.5 m/s².
