# Timber on the roads in the Scottish Borders

## “The Guid, the Bad & the Doonright Ugly”

Brian Young   Network Manager  
Scottish Borders Council

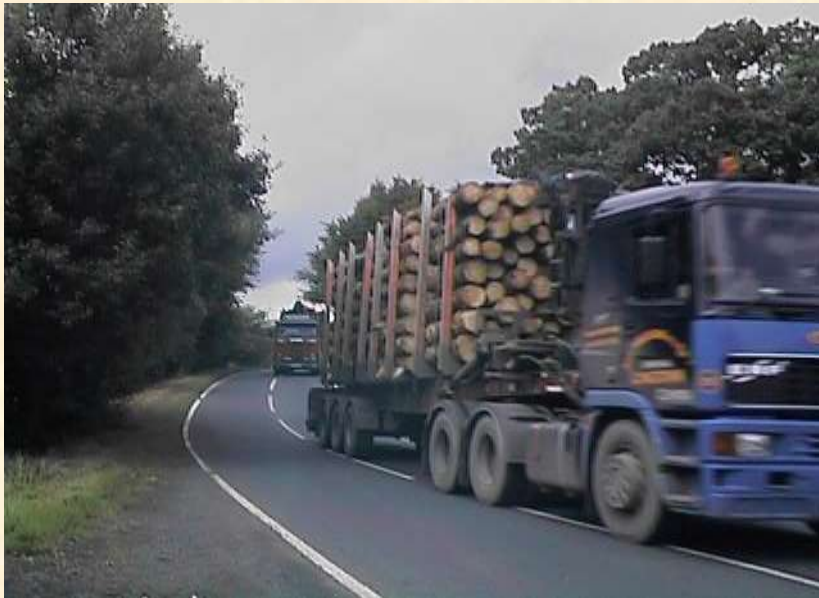
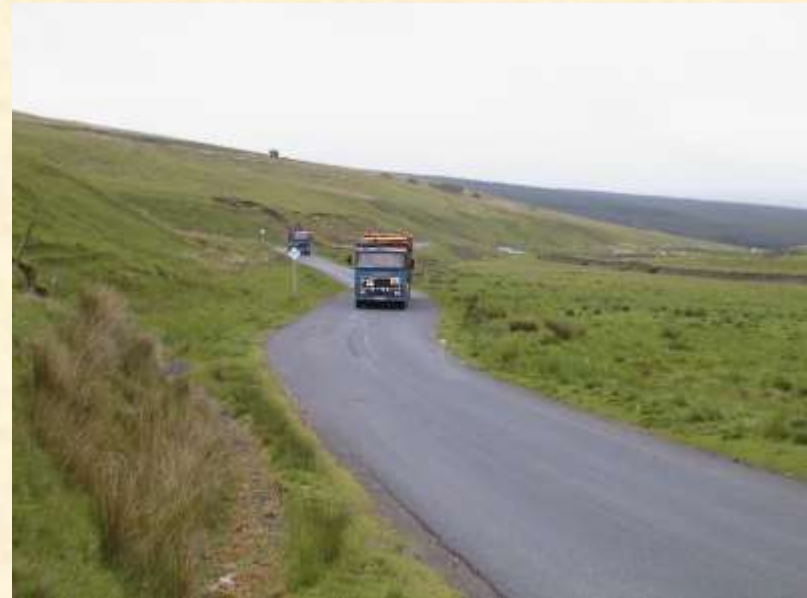
- **Security of Loads**

- Inadequate Strapping / Netting
- Unreported Shedding of Loads -
  - Number of occasions over the last few years where the public have reported shedding of loads.
  - Also evidence through debris and verge/road damage.
  - Police, generally, only involved if the shedding of a load, or part load, results in an accident.

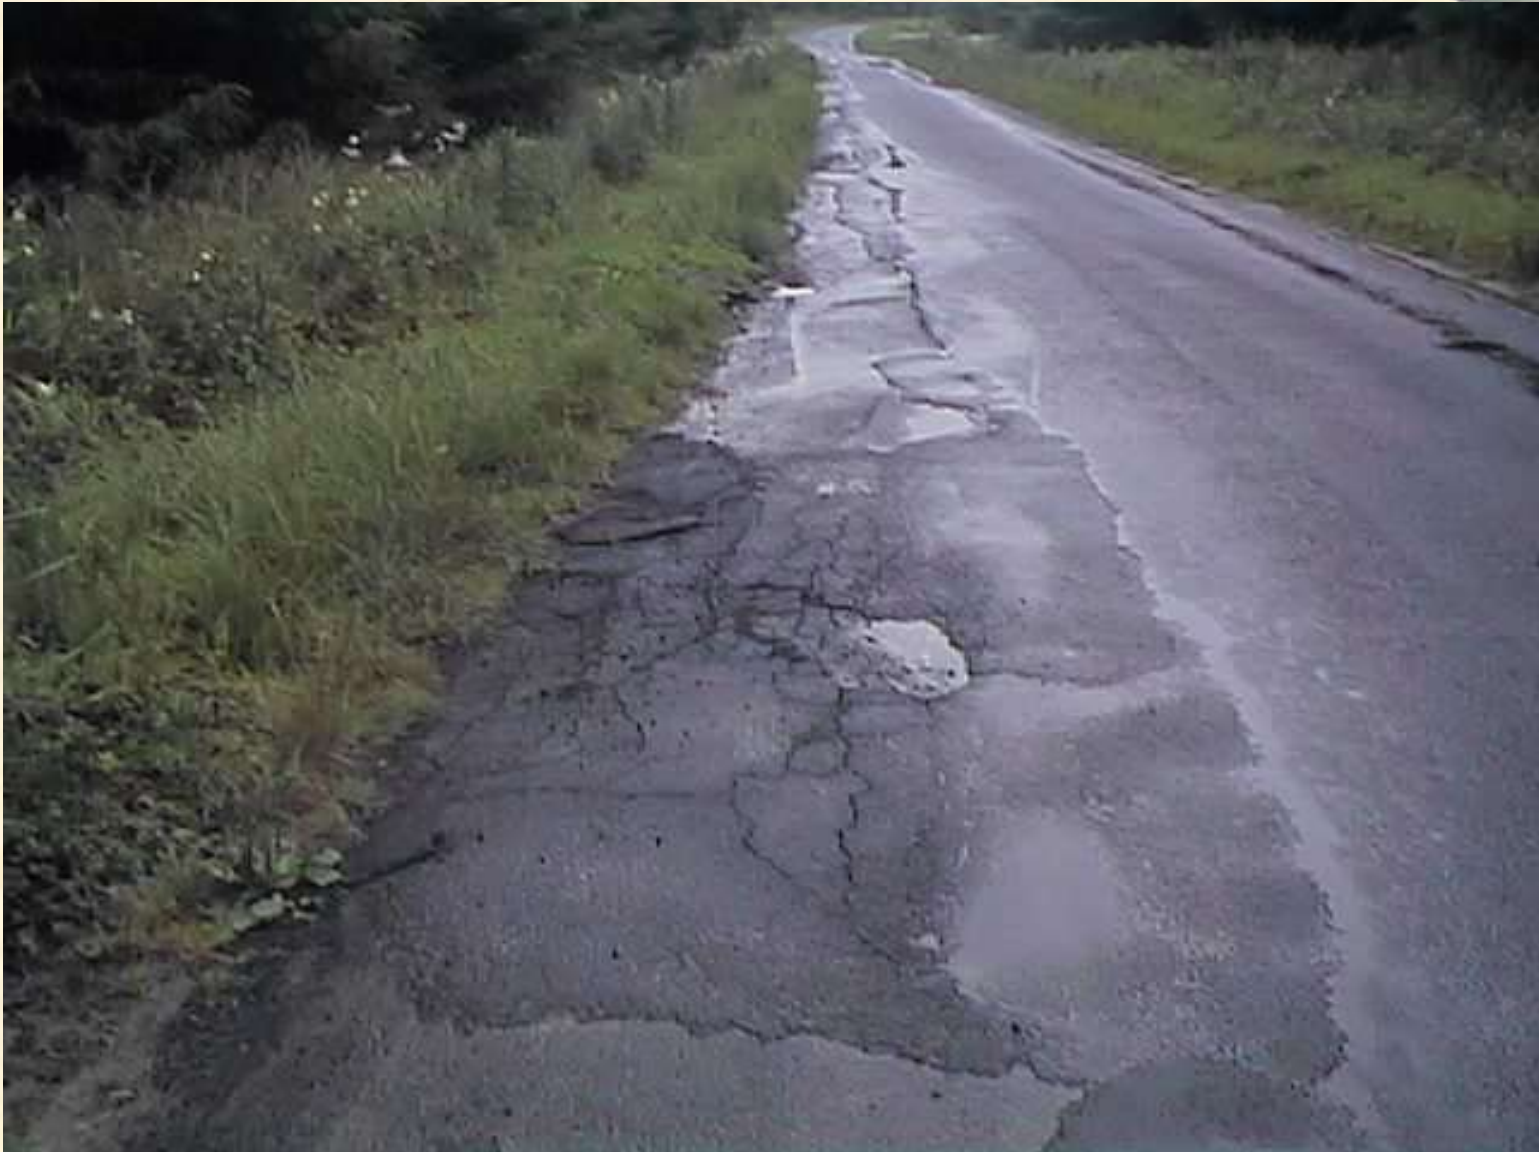
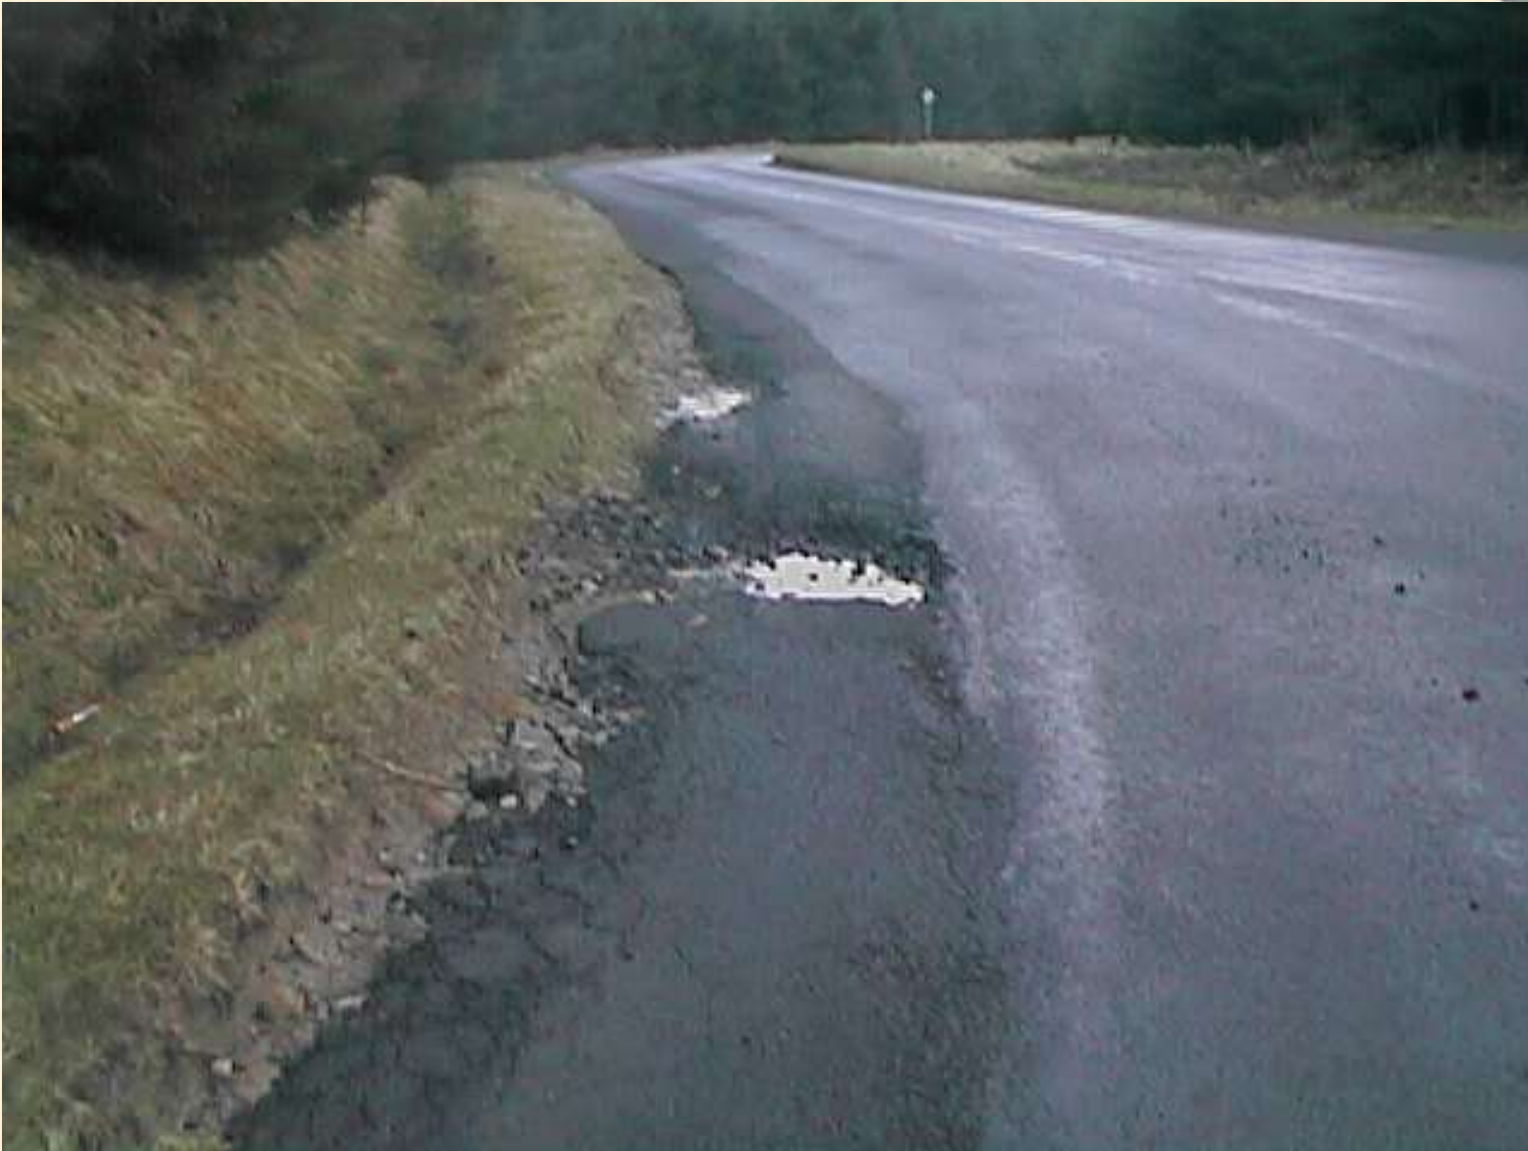
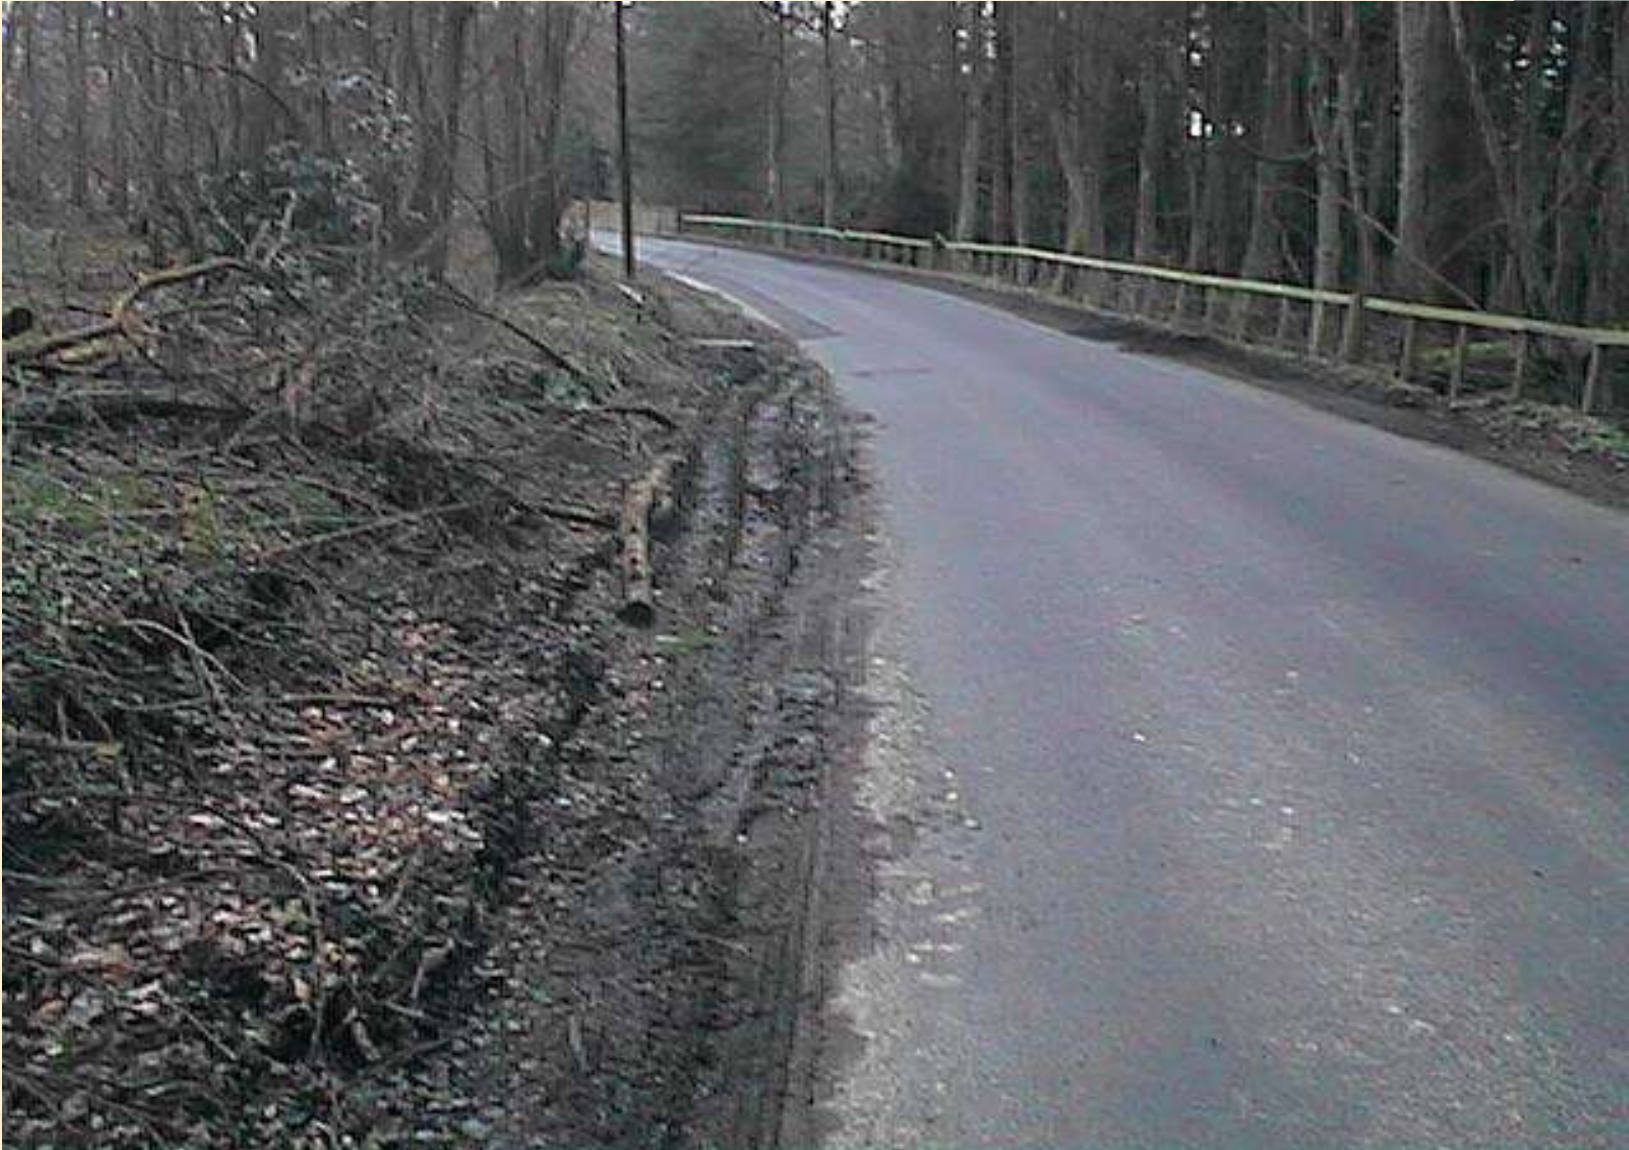
### **Damage to Roads**

- Verge Rutting due to Over-Run
- Resulting deep ruts are potentially dangerous for other road users.
- Road damage - ongoing Maintenance Burden

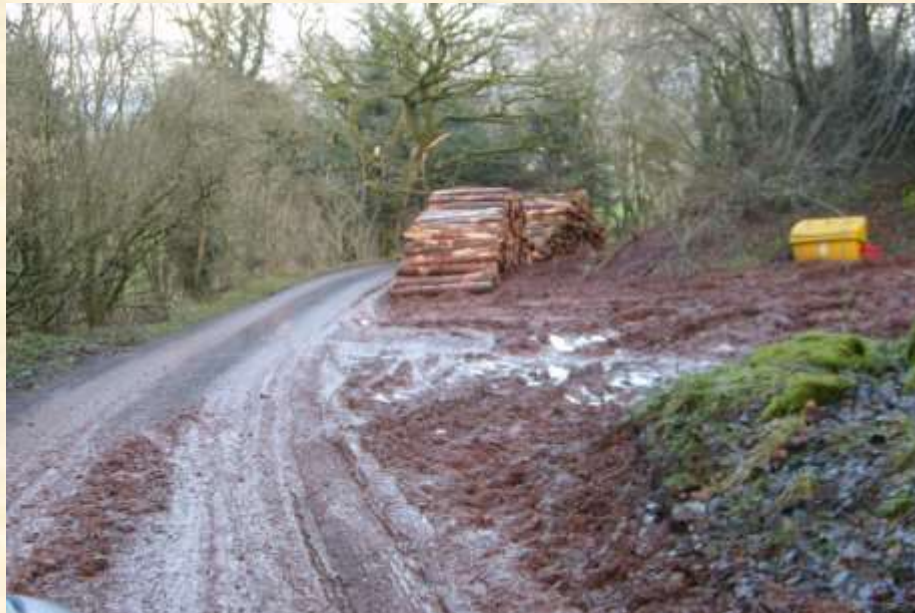
- Unofficial Loading of Stacked Timber Adjacent to a Public Road
- Mainly small quantities, but still not permitted without Local Authority approval.
- Can result in temporary blocking of the road and on occasions verge damage.

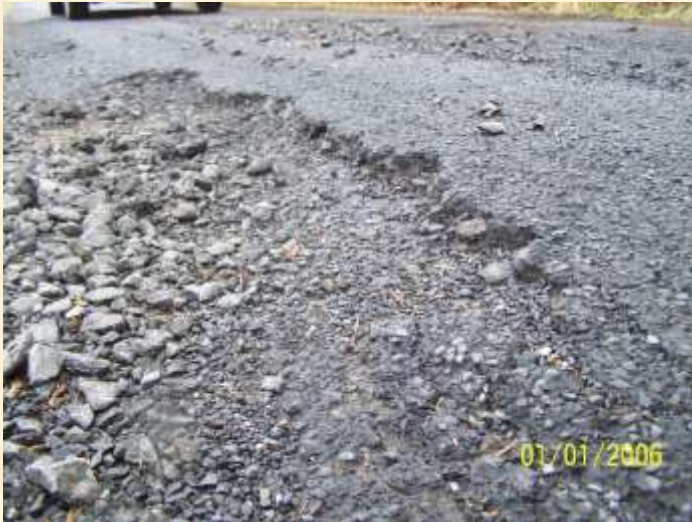
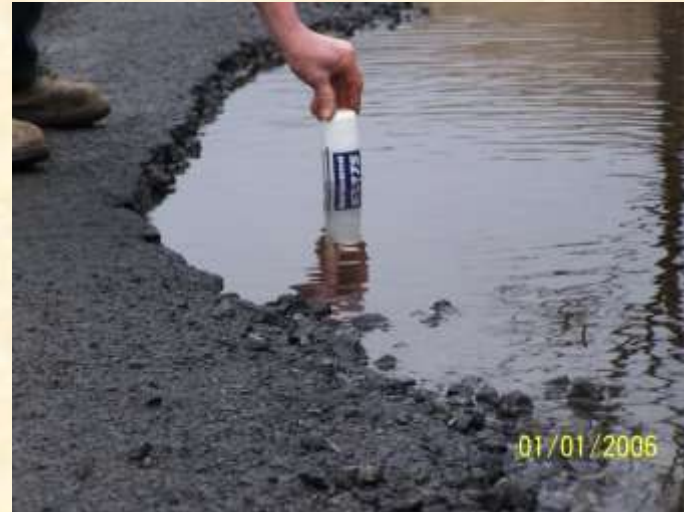
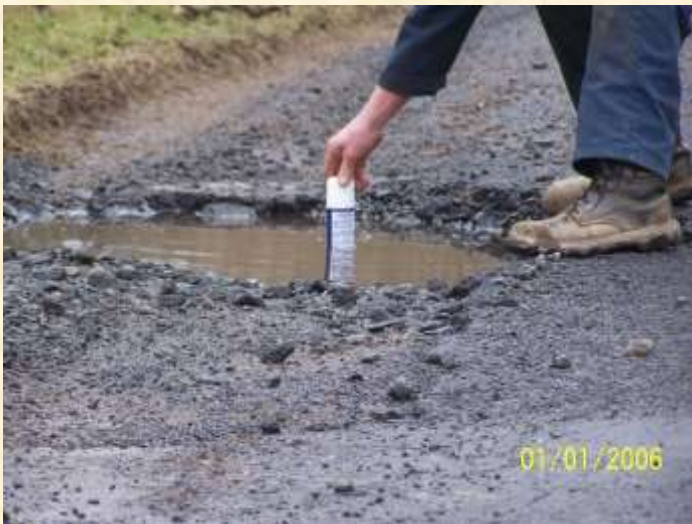
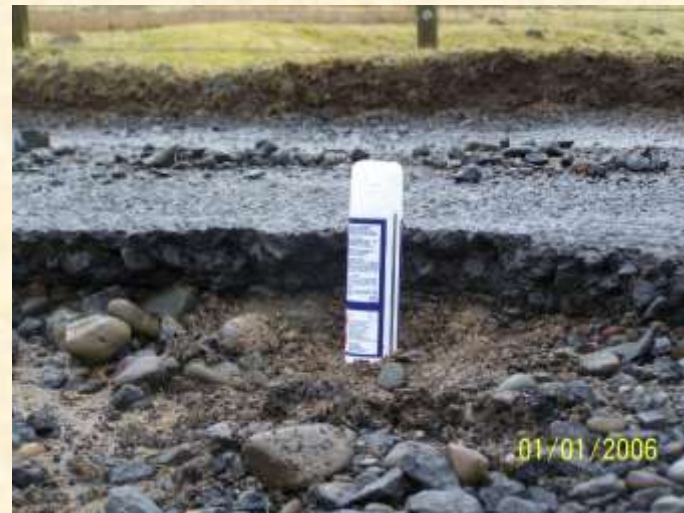
### Existing Damage

- Damage caused by timber lorries and the worst winter in the Borders for 30 years had taken its toll. Extensive timber extraction began on the road in April 2010, and due to the combination of fully-laden timber lorries and frozen temperatures, the road quickly deteriorated and became unsuitable for cars.

- £710,000 scheme over 8 km length
- improvements to existing drainage systems including resurrecting existing ditches on the top side of the road, clearing existing stone culvert cross drains and replacing collapsed culverts
- Passing places, both new and improved, to assist road users in passing haulage lorries and to prevent the deterioration of the road verges.
- the installation of a Glasgrid Reinforcing System
- carriageway resurfacing

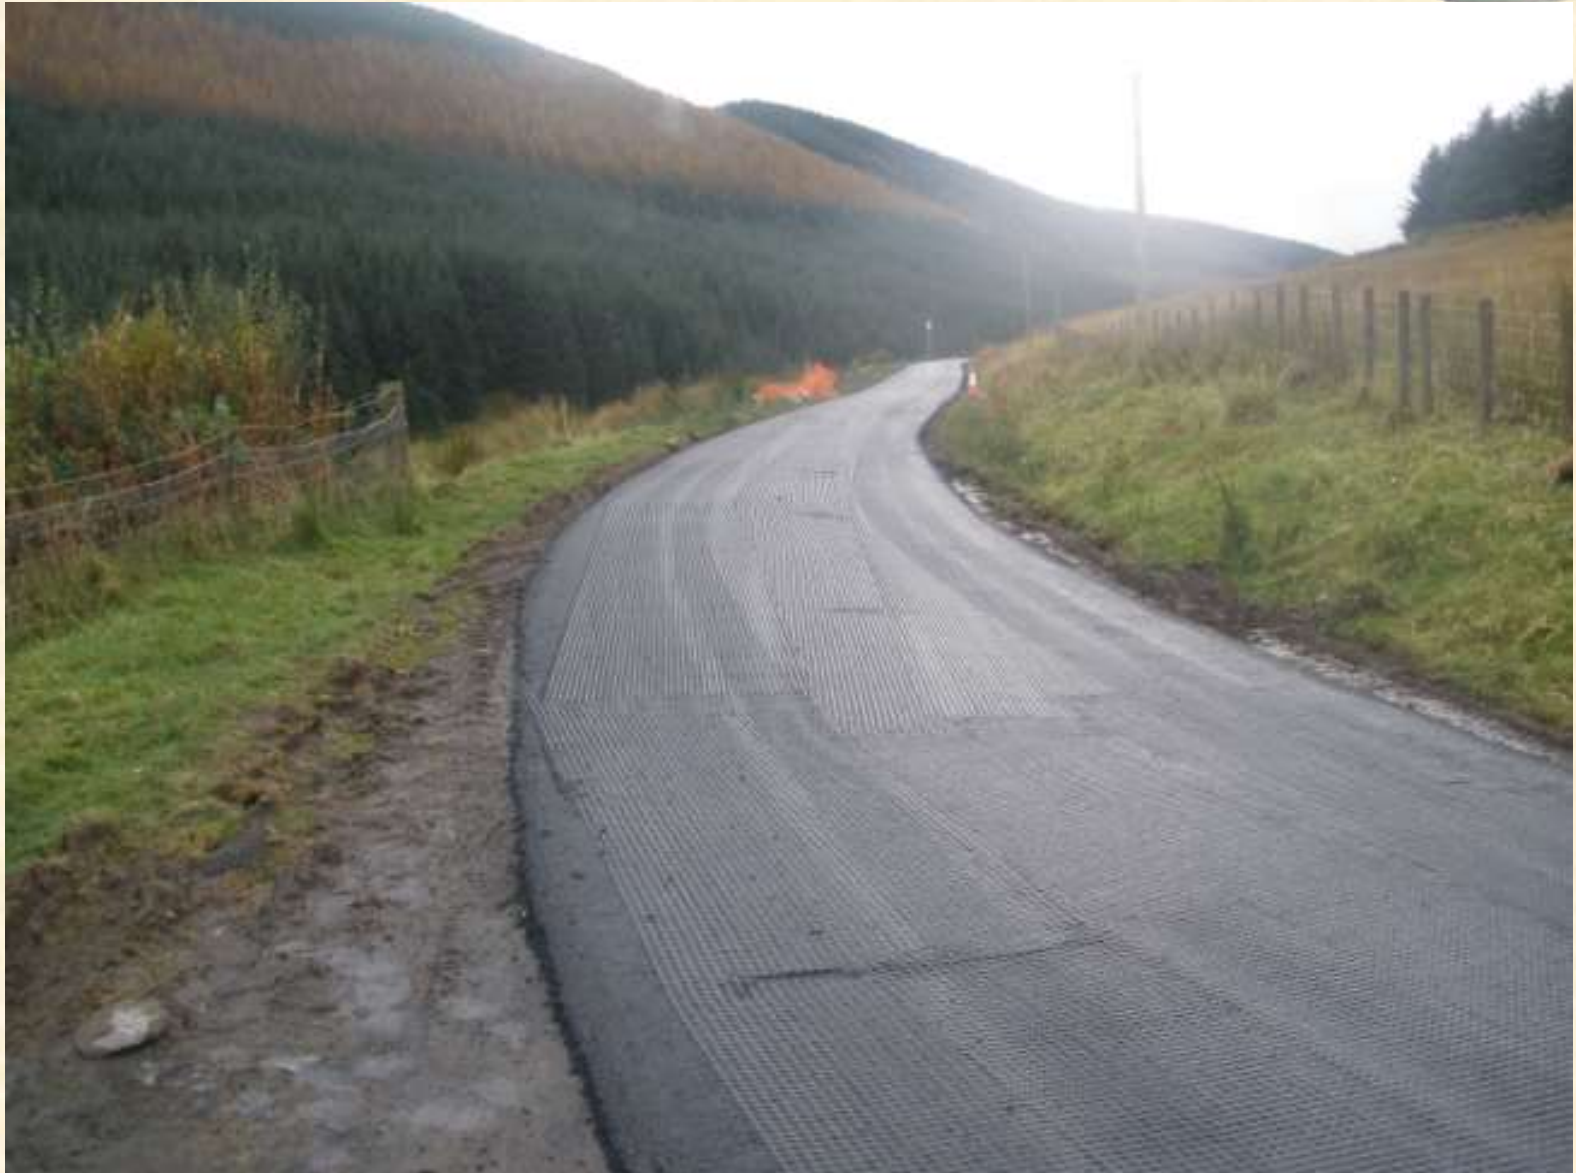
# The Good – Glasgrid Layer

- The repair work to the Potburn Road in the Ettrick Valley used a 'revolutionary' system. The new 'Glasgrid Reinforcing System' lays rolls of fibreglass mesh sheets under the tarmac carriageway to strengthen the road.

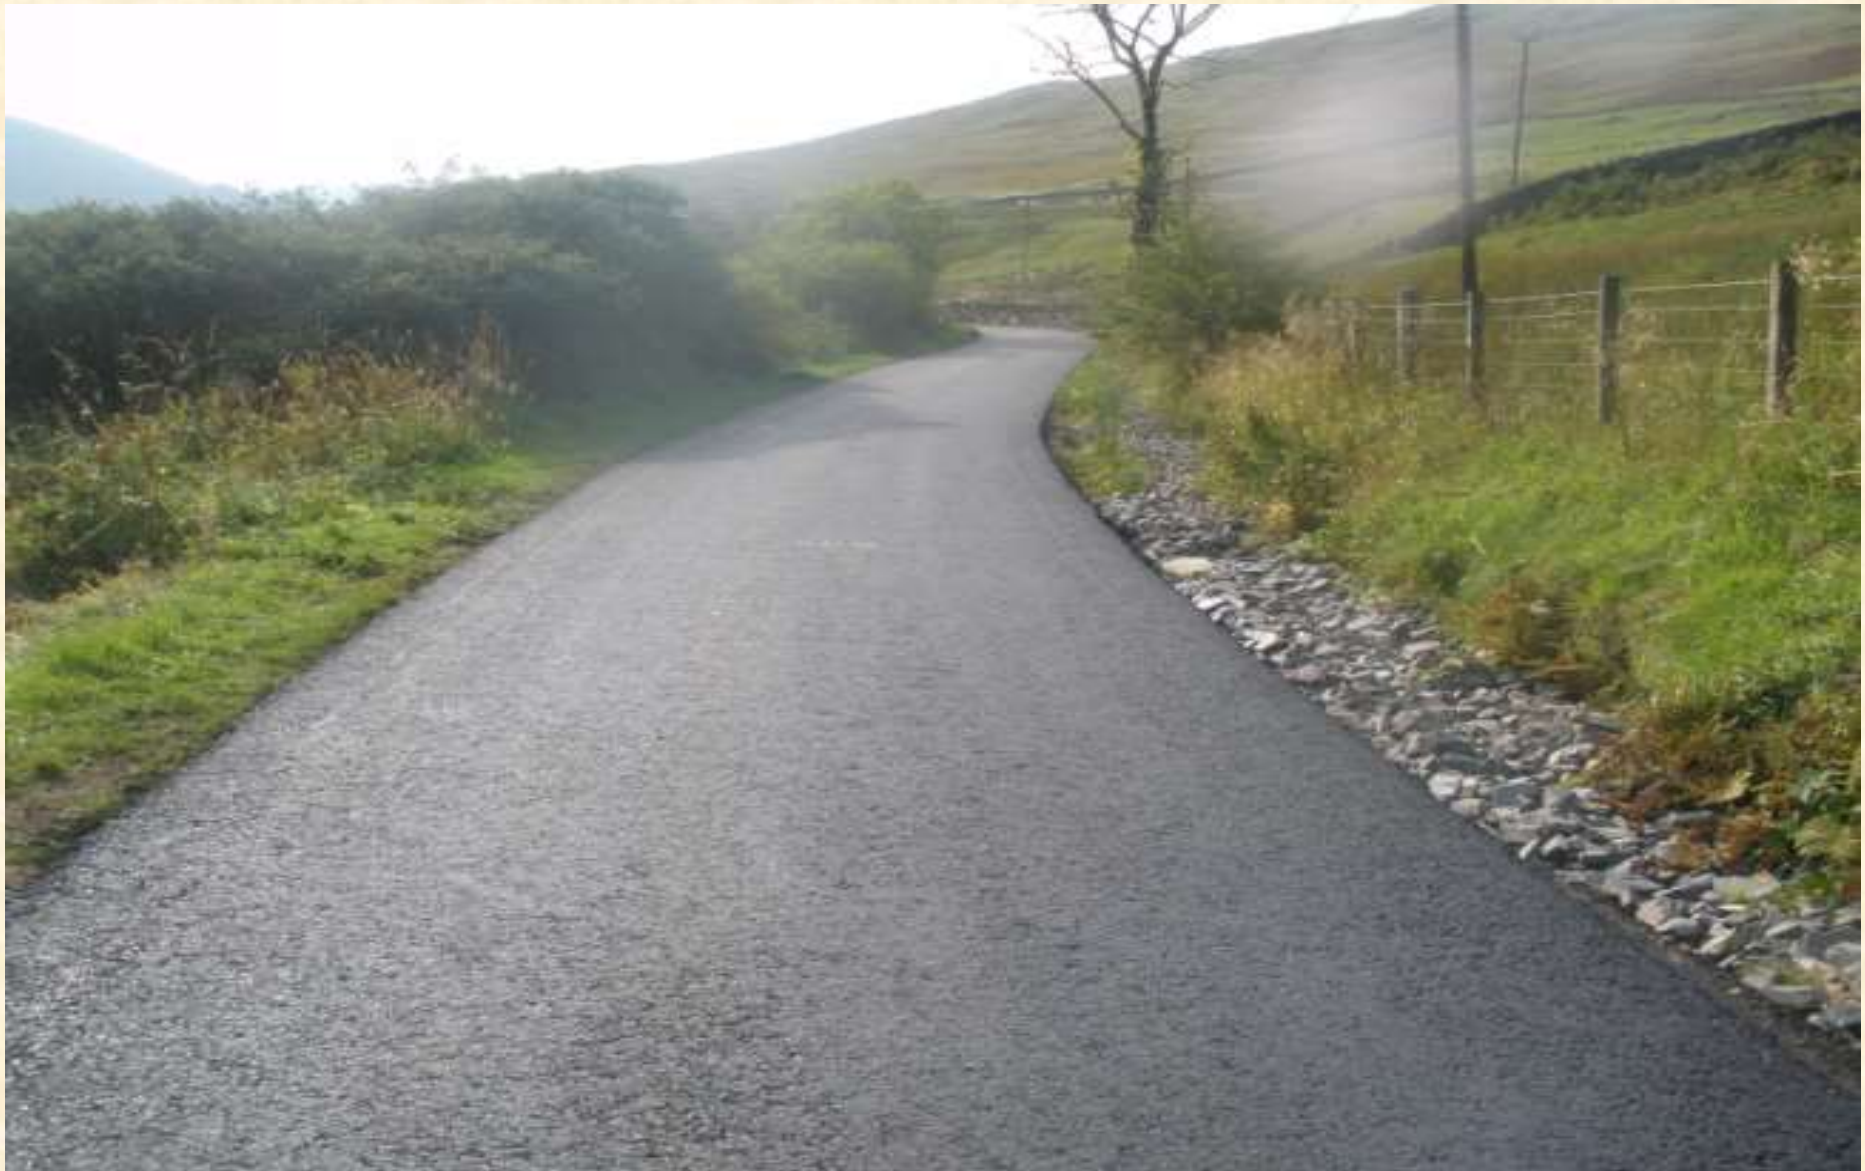
# The Good – Finished Product

- Improvements were undertaken over an 8km length of the single track road and the local community was kept up to date of progress on virtually a daily basis.
